# The Case Study of On-Line PD Measurement on in-service MV Cable Terminations

A 22.8 kV power plant is taken as an example, and this paper utilizes electromagnetic

field coupling mode for on-line PD measurement on all MV cable terminations in the power plant. The disturbing influence of external noises in the environment could be eliminated by means of choice ultra-high frequency as midband frequency. Among more than 5,000 cables terminations diagnosed by on-line partial discharge measurement, there are about 120 cable terminations having PD signals without surface erosion, and 20 cable terminations having PD signals and powder/carbonization on their surface. The cable terminations having PD signals without abnormal appearance are replaced and are cut off. It is verified that PD tracking exist inside the terminations. Comparing with PD patterns and dissection cable terminations, the defects and PD patterns both can be classified as several common kinds, and have some relationships between them. Therefore it is possible to establish a reliable relationship between PD patterns and defects.

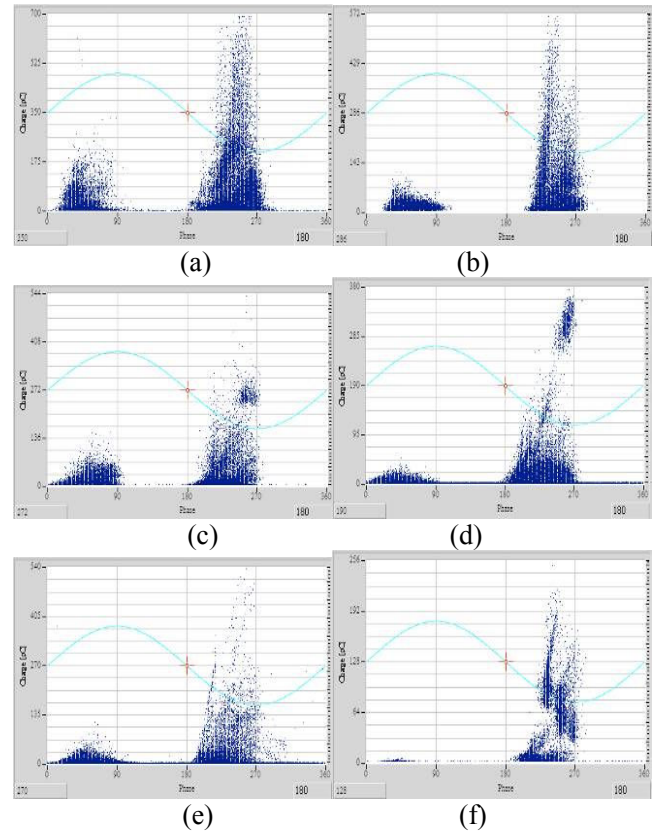
Figure 6 shows the partial discharge pattern measured in the field. The area of partial discharge is  $0^\circ$  to  $90^\circ$  and  $180^\circ$  to  $270^\circ$ , and the trace of partial discharge of negative half cycle are bigger than that of positive half cycle. The characteristics of these partial discharge patterns are alike to external partial discharge due to their peak partial discharge appears near the peak of applied AC voltage.

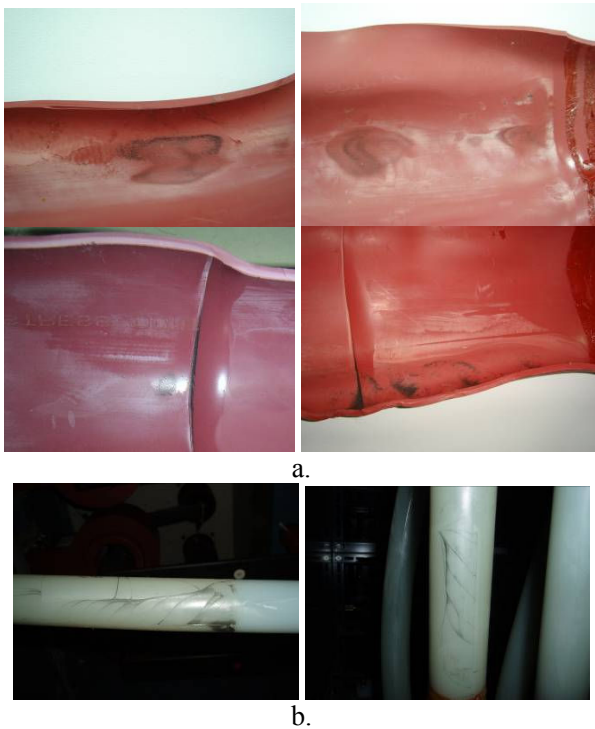
Figure 7

Because the sheath is hard, cutting sheath usually complies with outer-semiconductor damaged. The insulation material is also easily damaged while cutting outer-semiconductor. Aforementioned facts result in the irregular surface inside cable termination. Once workman does not smooth the irregular and fill the irregular with silicon grease, there will be a void leaved in cable termination. The inadequate heat shrink process also can cause void inside cable termination. These voids influent the distribution of electric field, and resulting inhomogeneous electric field. Hence, the partial over stress happens, and partial discharge activity exercises. Eventually, insulation material aging accelerates.

These cable terminations having partial discharge activities is replaced, and the replaced cable terminations were dissected. There is carbonization inside the cable terminations, as shown in figure 7. Two reasons can explain this situation. One is void left in the cable termination due to the inadequate heat shrink (7a). Another is excessive carving (7b).

According to dissection of replaced cable terminations, the majority reason of cable fault is workmanship. Therefore, the education of workman is the essential consideration to lower down the rate of cable faults.

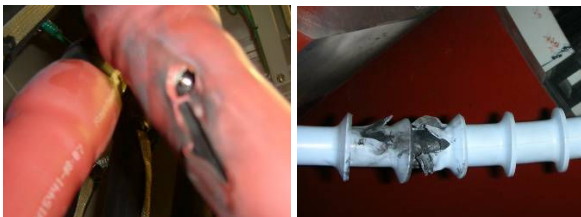
Figure 8

Once this kind of partial discharge activity starts, the carbonization will influence the distribution of electric field which will aggravate the aging adjacent the defects. Finally, a short circuit event occurs as shown in figure 8. The event of figure 8 is a kind of high impedance short circuit, and the initial fault current is low. Therefore, the insulation material is usually good without any discharge tracking, but there will be an obvious flashover tracking from defect to ground terminate. This is the property of the short circuit resulting from void discharge inside cable termination.

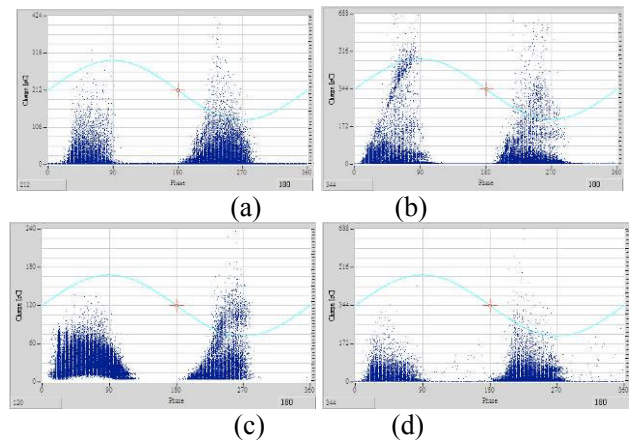
Figure 9 shows the partial discharge pattern measured in the field by means of on-line partial discharge measurement. The range of partial discharge is  $0^\circ$  to  $90^\circ$  and  $180^\circ$  to  $270^\circ$ , and the patterns of partial discharges of both half cycles are very close. After dissecting the cable terminations having the same patterns, the partial discharge pattern is classified as the stress cone does not contact well to outer-semiconductor layer.

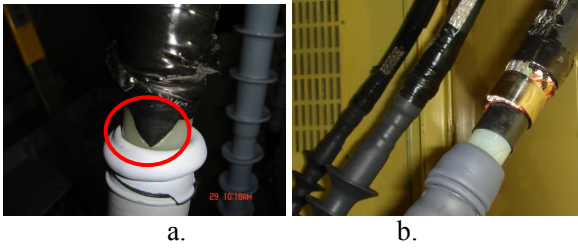
The main function of cable termination is to control the electric field at the cable terminates not to overstress insulator. There is a great intensity of electric field at the end of out-semiconductor without the existence of cable termination, and then the insulation is aging quickly. Therefore, the cable termination loses its main function as the stress control, this means that the cone does not contact to outer-semiconductor very well. This kind of mistake is usually caused by wrong installation process without following installation manual, and is only occurred at cold shrink cable.

Figure 10 are dissected cable terminations having the same pattern shown in fig. 9. Figure 10a shows that not only poor contact between stress cone and semi-conductive layer of cable, but also the irregular tapping result in partial discharge phenomena. Figure 10b shows another case which the stress cone does not contact well to outer-semi conductive layer but the edge of tape is smooth. Both figure 10a and figure 10b will cause partial discharge, but the former is worse due to the greater intensity of electric field at the irregular shape.

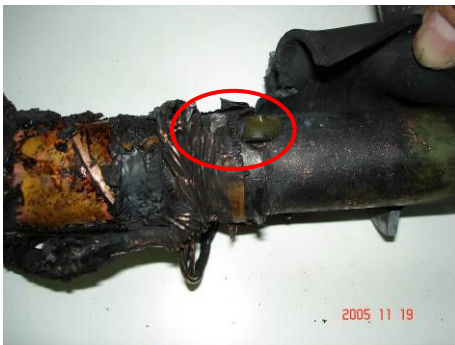
Figure 11 shows a fault event caused by such problem. The properties of this kind of faults are higher fault current and obvious tracking from conductor to grounded wire.

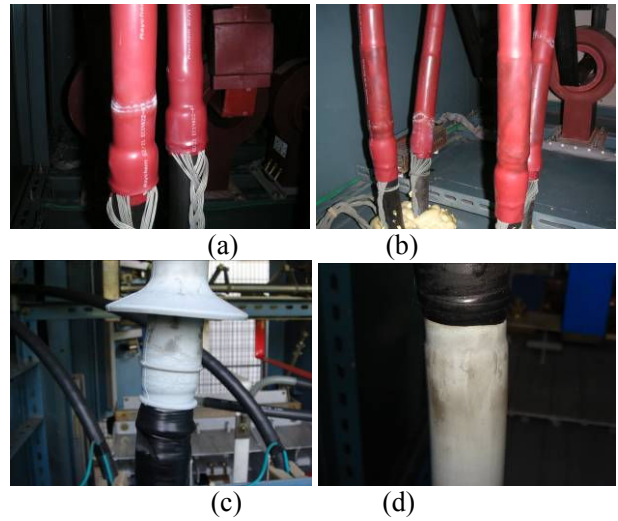
Besides incorrect installation, there are other factors resulting in partial discharge. These environment-caused partial discharge phenomena could be easily detected by visual inspection. Figure 12 shows the partial discharge trace in the surface of cable terminations. These partial discharge phenomena usually resulted in un-uniform gradient of electric field relating to humidity and shape. The dangerous of these partial discharges is usually low degree. There is a potential danger that the trace bridging conductor and grounded wire will cause flashover along the surface, as shown in figure 13.

The amount of surface partial discharges depends on environment. As the humidity is high, the amount of surface partial discharge is large. Sometimes ultraviolet and sound comply with heavy partial discharge activities.

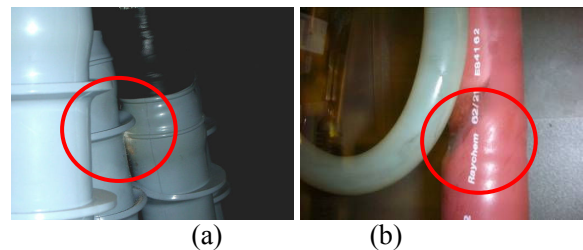
Figure 14

Another factor affecting external partial discharge is insufficient distance between cables, especially for the same phase cables. There is a different potential between cables due to un-uniform impedance along the cable. As the potential difference is higher than the breakdown voltage of air, partial discharge will occur, as shown in figure

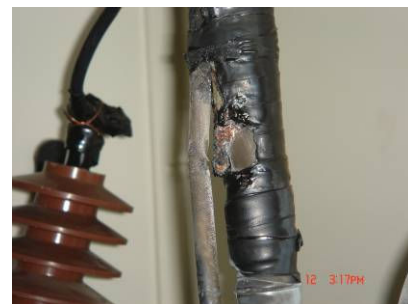
Figure 15

14. if the discharge is disregarded, the fault event shown in figure 15 happens.
