A Study on Underground Discharges due to Non-uniform Fields

Min-Yen Chiu Chang-Hsing Lee
Power system Diagnostics Service Co., LTD.
Hsingchu Taiwan
standby@pdservice.com

1. Introduction

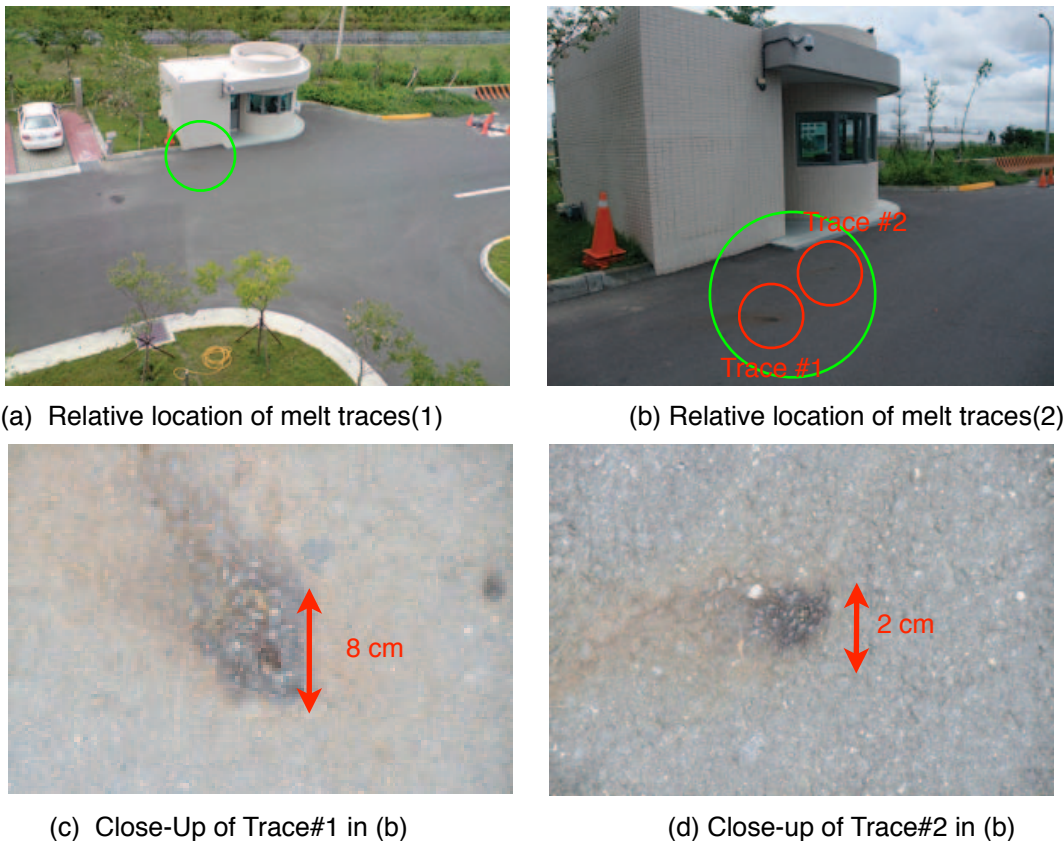
In one thunderstorm day, one factory was encountered lightning stroke and, unfortunately, some information systems were damaged at the same time. Therefore, an inspection was carried out, and one strange phenomenon was reported that there were melt traces on the surface of asphalted road closed to the building. The melt traces on the surface of asphalted road were shown in fig. 1.

Fig. 1 Melt traces on the surface of asphalted road

According to the Lightning Location System (LLS) shown in fig. 2, two lightning strokes were reported at that time in this area and the smallest lightning current was 17.6 kA. However, these melt traces didn't show serious destruction due to the high lightning current, but only small areas with 8 cm-diameter and 2 cm-diameter. Hence, the melt traces were not resulted from direct lightning strike, and the lightnings were supposed to strike on the lightning rod. The damaged information systems could be resulted from the ground potential rise (GPR) and the relative circuit might be without proper surge protection.

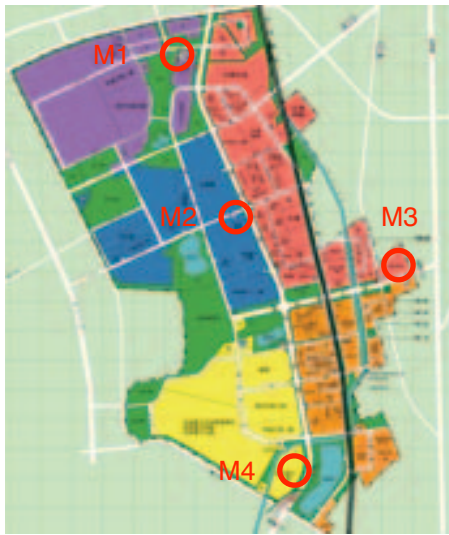
(b) Melt trace at M2 of (a)

(d) Melt trace at M3 of (a)

(c) Melt trace at M4 of (a)

Fig. 2 Melt traces on the surface of the asphalted road in Tainan Scient Industrial Park, Taiwan

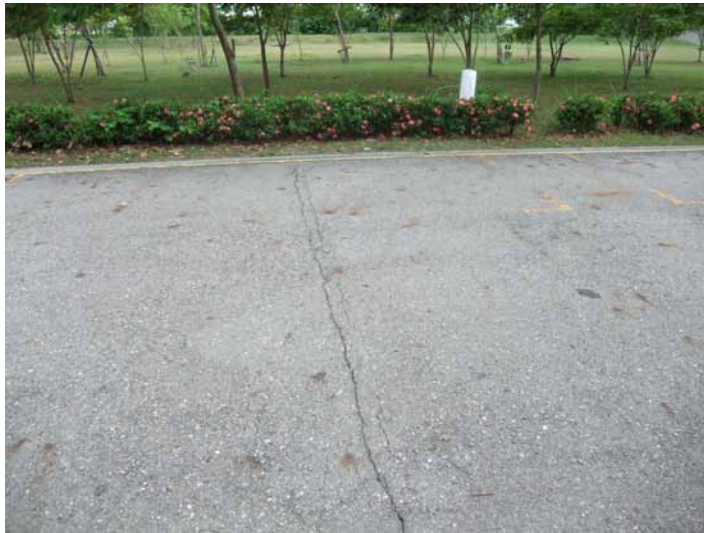
(a) Switchyard of substation

Fig. 3 Melt traces at M1 of Fig. 2(a)

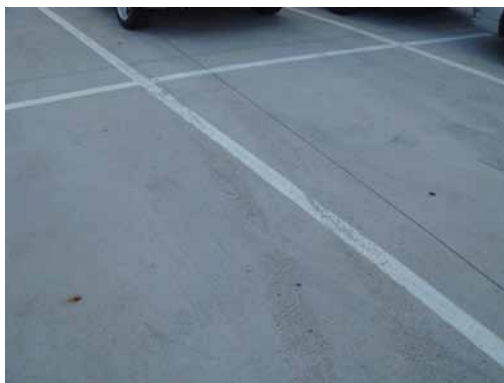
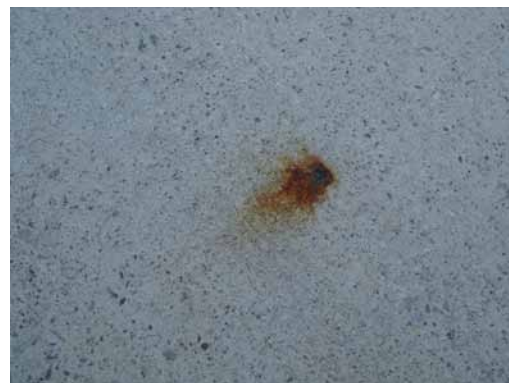
Fig. 4 Melt traces at concreted parking lot in Ilan (east Taiwan)

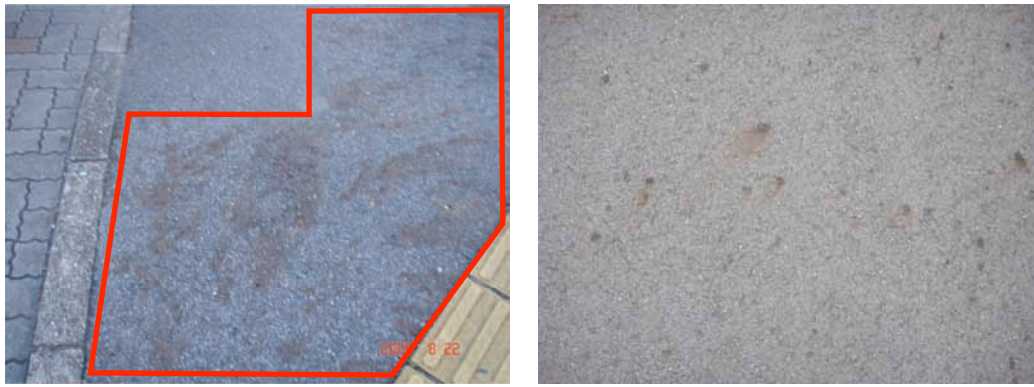
(a) Sakae-machi

(b) Miyazaki

Fig. 5 Melt traces on the surface of asphalted road in Japan

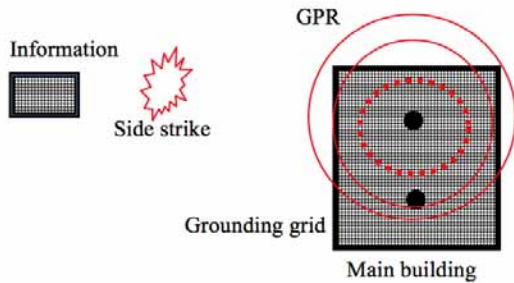
Figure 6 shows the grounding grids of information and main building, and there are no solid grounding wire connecting these grids. As lightning stroke the lightning rod on the roof of main building, the 18 kA lightning current would result in a GPR in the main building, and the ground potential in information remained low.

Fig. 6 Grounding grids of buildings

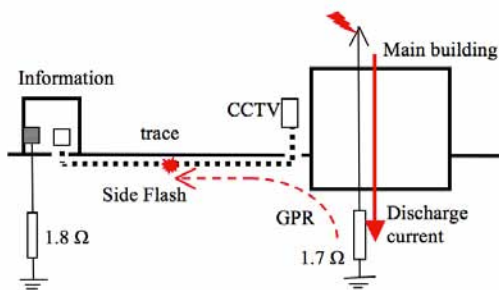
Fig.7 Grounding

The asphalted road, consisting of asphalt and gravel, forms an insulator, and fig. 8 shows there are three layers below the asphalted road: asphalt with gravel, soil, and a mix of sand, stones, and gravel. Because the conductivities of the three layers are different, the interfacial polarization might result in space charge on the surface of asphalted road. As lightning stroke on the lightning rod, the GPR will fully applied on the asphalted road as shown in fig. 7. Because of non-uniformly electric field caused by GPR, the built-up space

charge also non-uniformly distributes along the surface of the asphalted road. Hence, there would be an side flash on the asphalted road while the enhanced electric field caused by built-up space charge excess the breakdown electric field of air. The size of melt trace could vary with the energy stored space charge.

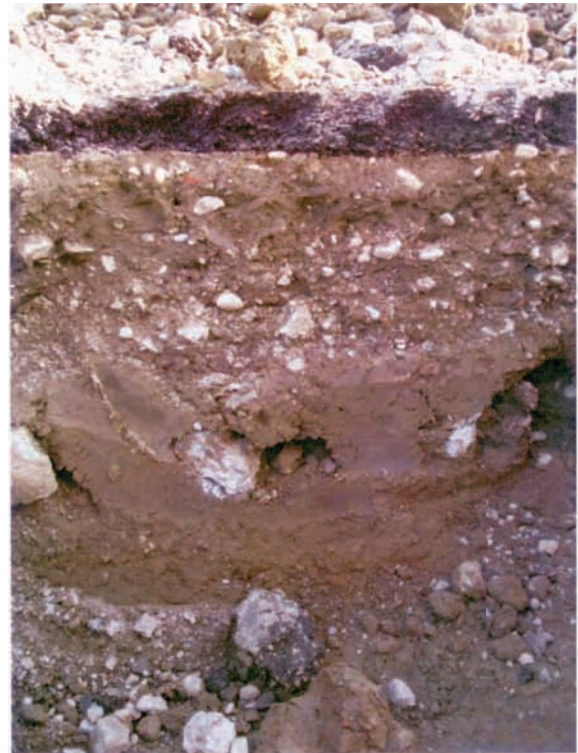
Fig. 8 Soil layer of asphalted road
