Case study of Lightning Stroke on Wind Turbine Blade in Middle Taiwan

Shih-Shong Yen, *Industrial Technology Research Institute*
 Chang-Hsing Lee, Min-Yen Chiu, *Chan-Ching Electric Technique Consulting. Co., LTD*
 Sheng-Cheng Huang, *Precision International Corp.*

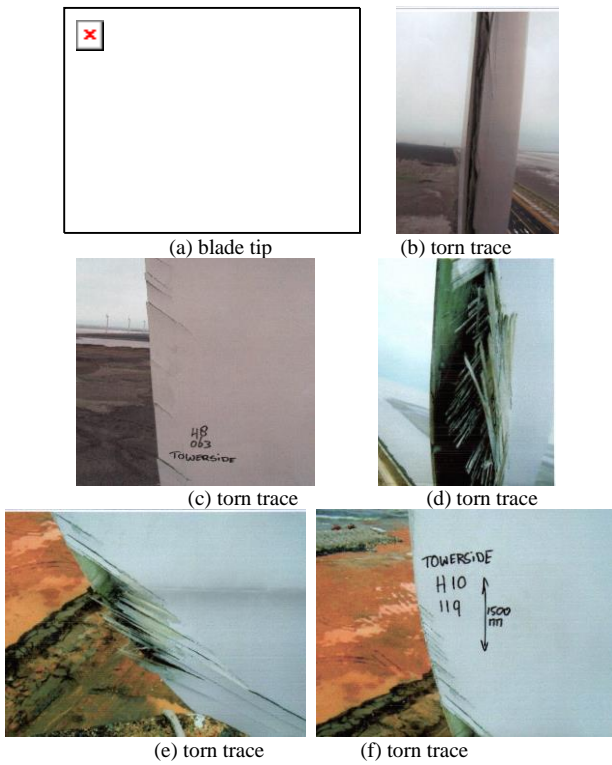
At afternoon in 26th May 2008, the wind turbine blade located at TaiChung thermal power plant is broke by unknown reason. The broke blade is shown in figure 3. Fig. 3 shows that there was a lightning stroke on the tip of the blade, and the broke blade is torn by specific force instead of burned by heat.

Fig. 3 damaged blade caused by lightning stroke

From fig. 3(a), the main cause of blade broke is lightning stroke. There are two ways lightning damaging wind turbine blade. One is burned by heat due to the lightning current along the down conductors. Another is tore by the electromagnetic force induced by lightning current flowing along the down conductors. There are no burning marks shown in fig. 3(b) to fig. 3(f), and the former reason can be excluded. The cracks shown in fig. 3(b) to fig. 3(f) are along the down conductors, and are a kind of torn trace. Hence, the reason causing blade broke is the electromagnetic force induced by the lightning current along down conductors.

By the inspection of the damaged wind turbine blade, the main reason is the insufficient withstand lightning current of the wind turbine blade. In this case, the amplitudes of the lightning currents are under the average range. Hence, the wind turbine blade are recommended to pass the withstand lightning current test, and the reliability of the wind turbine generator can therefore be improved.

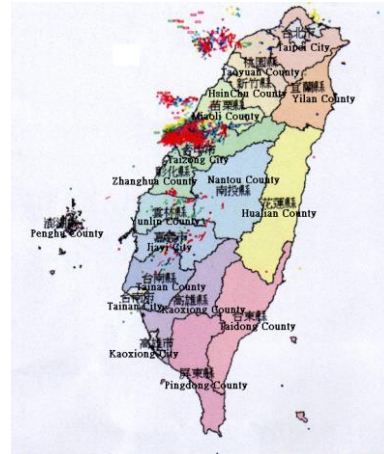
From the data gathered by LLS, there were lightning adjacent TaiChung thermal power plant as shown in figure 4. According to the lightning data, the lightning time and the event time is coincided. However, there is about 1 km mismatch between the location of lightnings and TaiChung thermal power plant as shown in figure 5. Because the timing system is synchronized by the network and the location always has certain system error, the lightning location is treated as locating at the broken wind turbine generator.

Fig. 4 lightning flash distribution recorded by LLS

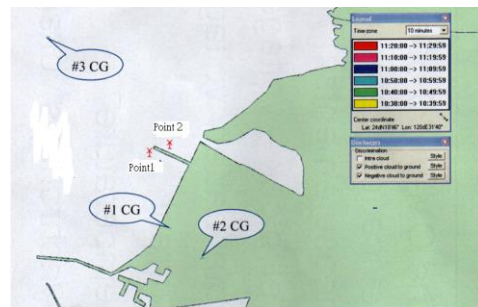
Fig. 5 recorded lightning flash location near Taichong

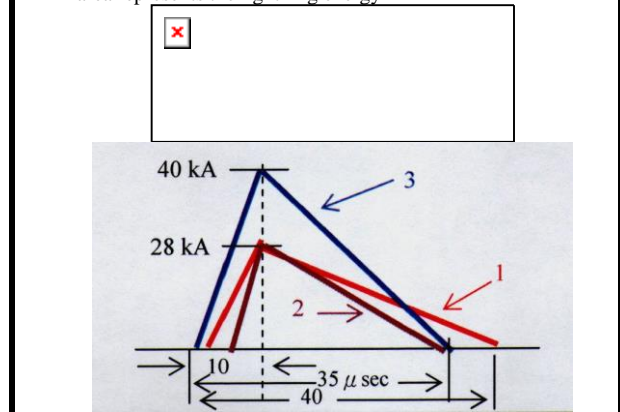
2) below chart shows the waveform of lightning current, and the area represents the lightning energy

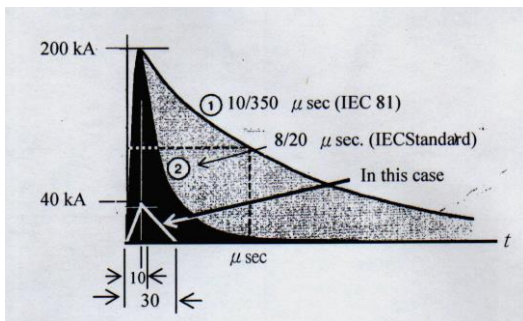
According to table 1, recorded lightning currents are not larger than the 200 kA lightning current specified in IEC 61400-24, and are closed to the average lightning current in Taiwan. Comparing recorded lightning waveforms with the lightning waveform specified in IEC, the recorded lightning waveforms are small as shown in figure 6. This implies that the withstand lightning current of the wind turbine blade is obviously insufficient.

Fig. 6 Lightning current comparison between recorded data and IEC standard

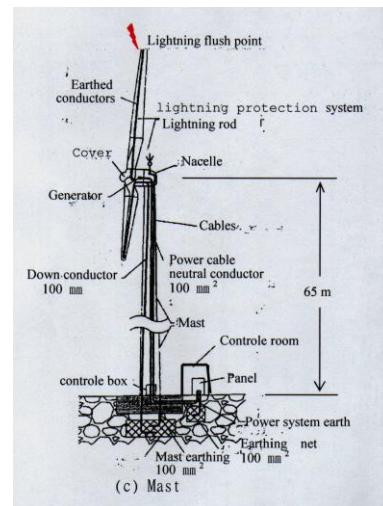
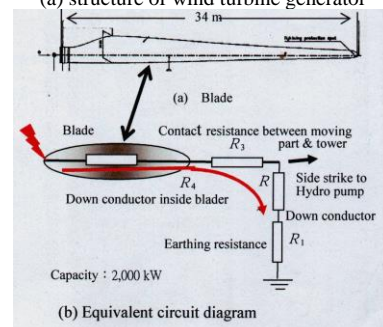
Fig. 7 diagram of side stroke

Beside the wind turbine blade broke, there is side stroke happened between down conductor and hydro pump. Figure 7(a) is the structure of wind turbine generator, and figure 7(b) is the equivalent circuit of the ground path of the wind turbine generator. As lightning current flows through down conductors, the voltage distribution is formed by line impedance. Because the lightning current did not flow through the housing, the potential is close to ground potential. Hence, there is a large voltage drop between the down conductor and the housing, and the side stroke happened. This phenomenon verified that there was a lightning stroke on the wind turbine generator.
