# The Case Study of On-Line PD Measurement on in-service MV Cable Terminations

A 22.8 kV power plant is taken as an example, and this paper utilizes electromagnetic

field coupling mode for on-line PD measurement on all MV cable terminations in the power plant. The disturbing influence of external noises in the environment could be eliminated by means of choice ultra-high frequency as midband frequency. Among more than 5,000 cables terminations diagnosed by on-line partial discharge measurement, there are about 120 cable terminations having PD signals without surface erosion, and 20 cable terminations having PD signals and powder/carbonization on their surface. The cable terminations having PD signals without abnormal appearance are replaced and are cut off. It is verified that PD tracking exist inside the terminations. Comparing with PD patterns and dissection cable terminations, the defects and PD patterns both can be classified as several common kinds, and have some relationships between them. Therefore it is possible to establish a reliable relationship between PD patterns and defects.

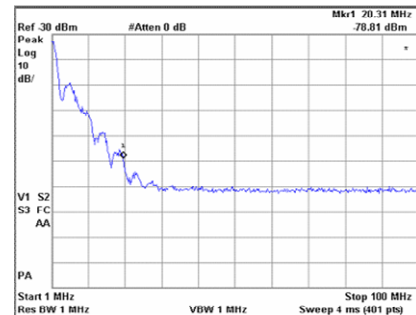
The bandwidth of conventional HFCT and Rogowski coil is below 20 MHz. Unfortunate, the bandwidth of noise from power system is also in the range. Figure 3 is the noise spectrum of an industry plant measured by authors. Therefore, the interpretation of on-line partial discharge measurement becomes difficult due to the low signal-noise-ratio. On way to overcome this problem is to utilize a sensor with bandwidth of 30 MHz ~ 1.3 GHz(UHF sensor). The signal-noise-ratio is improved as the higher measuring frequency is used[6].
