Case study of Lightning Stroke on Wind Turbine Blade in Middle Taiwan

Shih-Shong Yen, *Industrial Technology Research Institute*
 Chang-Hsing Lee, Min-Yen Chiu, *Chan-Ching Electric Technique Consulting. Co., LTD*
 Sheng-Cheng Huang, *Precision International Corp.*

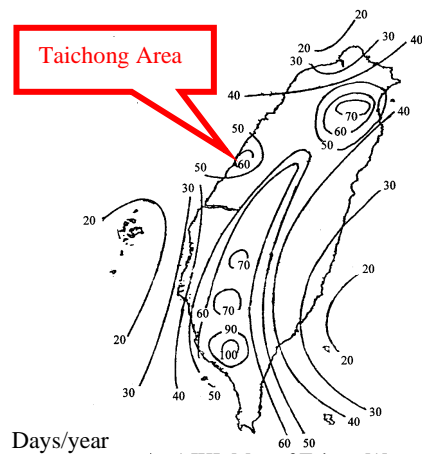
ig. 1 IKL Map of Taiwan[1]

Figure 1 shows the isokeraunic Level of Taiwan, and figure 2 is the lightning flash density of Taiwan. Fig. 1 and Fig. 2 show that Taiwan is a high lightning density area. Because the wind farm is usually located close to the coast, the probability of wind turbine generator stroke by lightning is higher.

From fig. 1 and fig. 2, Taiwan is the area with high lightning flash density. Based on experience, the wind turbine generator can't prevent the lightning strike even if they are installed at the coast with normal lightning flash density.
