Recognition of partial discharge defects in cable terminations

Abstract--As reported in very researches, the majority failure mechanism in cable terminations is predominantly involving partial discharge deterioration caused by voids, contaminants and protrusion. The partial discharge measurement is an effective way to detect such defects. However, no research shows the relation between the magnitude of partial discharge and remaining life of cable termination. Hence, it is hard to make decision to replace the unqualified cable termination immediately or lately for an in-service cable termination, while the partial discharge activities are measured. Based on authors' experiences, different defects have different ageing speed to breakdown. Therefore, recognition of defects is an alternative way to assess the degree of risks. This paper sets up a series test to figure out the properties of partial discharge activities caused by different defects, including wrong position of stress cone, void left, tape left, and needle pricked. Test results show the different properties of different defects, and these characteristics can be used to recognize defects inside cable termination.

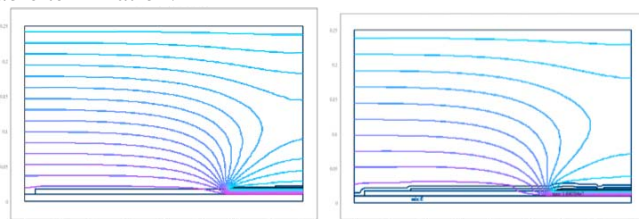
Figure 1 potential gradient distribution

The potential gradient on the end of cable is much higher than on the middle of cable, and the lifetime of cable will be decreased. Therefore, a cable termination is used to restrict the potential gradient into a tolerable rang. The different potential gradients of cables with/without cable terminations are shown in figure 1. In figure 1, the potential gradient of cable with cable termination is much lower than that of cable without cable termination.

(a) without cable termination (b) with cable termination

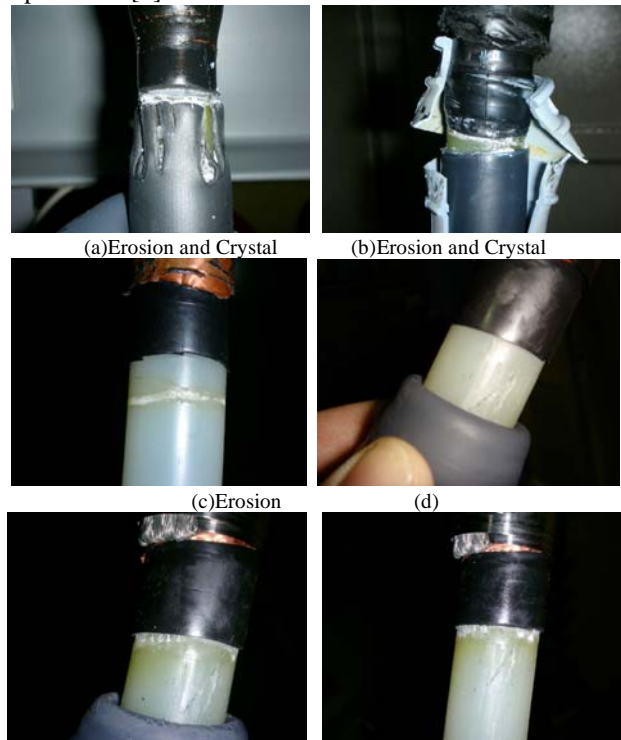
All these defects will enhance potential gradient, and can be detected by partial discharge measurement. Unfortunately, more than half of them can't be detected at commission test except some serious defects, and the defects need time to develop to the degree being detected. Figure 2 shows the ageing procedure caused by wrong position of stress cone, and compare with [3].

(e) after one year (f)after two year
Figure 2 ageing procedure of wrong position of stress cone

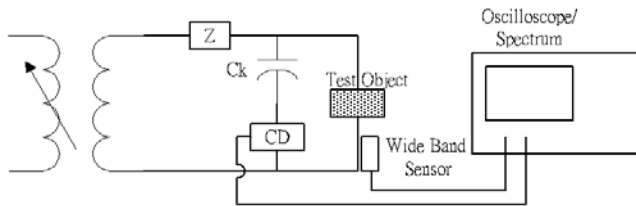
Figure 3 test arrangement

The purpose of this paper is to measure the partial discharge activities resulting from different defects, and then classifies these results to assess the kinds of defects. Therefore, authors do partial discharge measurement according to IEC 60270[1], and measure the spectrums. The test arrangement is shown in figure 3. The applied voltage is rated phase-to-ground voltage rather than phase-to-phase voltage.

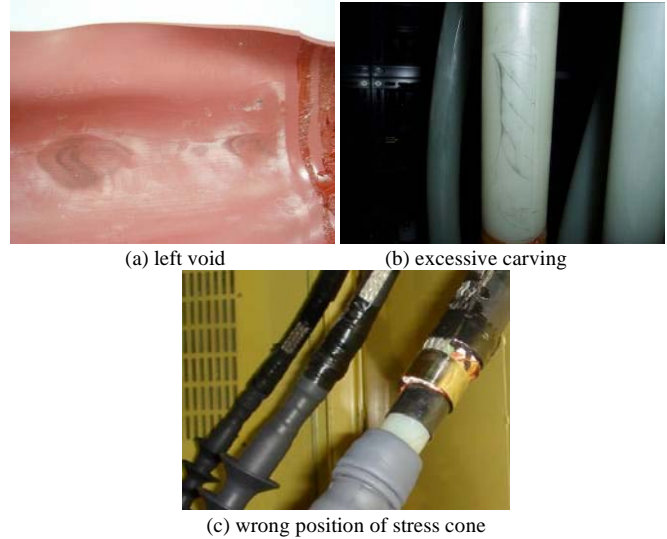
Figure 4 common defects caused by workmanship

According to authors' experiences, the defects in cable terminations are usually caused by workmanship[2], as shown in figure 4. Hence, the defects simulated in the test are wrong position of stress cone and left pollutants including void, tape, and metal particle, and the detail are shown as follows.

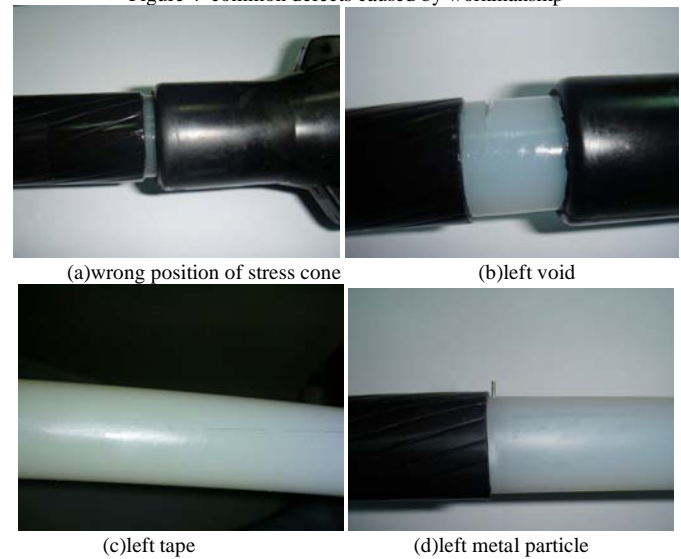
Figure 5 artificial defects

- Wrong position of stress cone: stress cone and out-semiconductor are 2 mm apart, as shown in figure 5a.
- Void left: insulation are dug by a small part, and is not filled by silicone, as shown in figure 5b.
- Tape left: before installing cable termination, a hairlike semiconductor tape is put on the surface of insulation, as shown in figure 5c.
- Metal particle left: a 2 mm length needle is pricked into insulation, as shown in figure 5d.

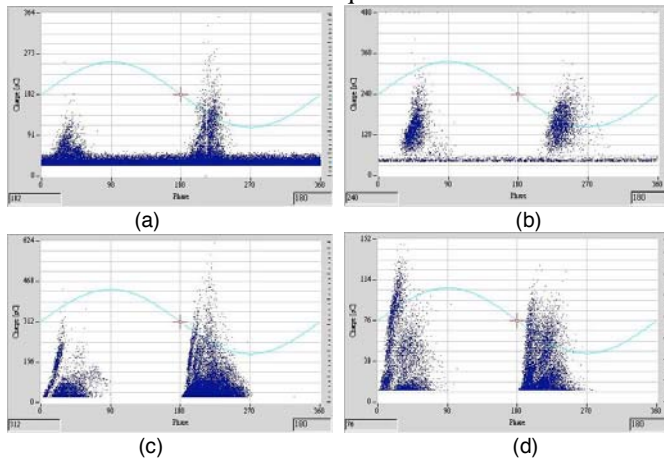
Figure 6 phase-resolved pattern

Figure 6 shows the partial discharge pattern of specimen with wrong position of stress cone. The ranges of partial discharge distribution are 0° to 90° and 180° to 270° , and the patterns of partial discharges of both half cycles are very close. And the peak magnitudes of both half cycles locate close to the middle of the first and third quarters.

Figure 9 shows the partial discharge pattern of specimen with needle pricked into the insulation. The areas of partial discharge are 0° to 90° and 180° to 270° . The patterns of partial discharges of both half cycles are very close. These patterns like those shown in figure 6, and the difference between them is the envelope of figure 9 are wide and the envelope of figure 6 are steep.

The laboratory tests show that phase-resolve pattern can be used to distinguish between defects caused by workmanship, as shown in table 1, and figure 6 to figure 9.

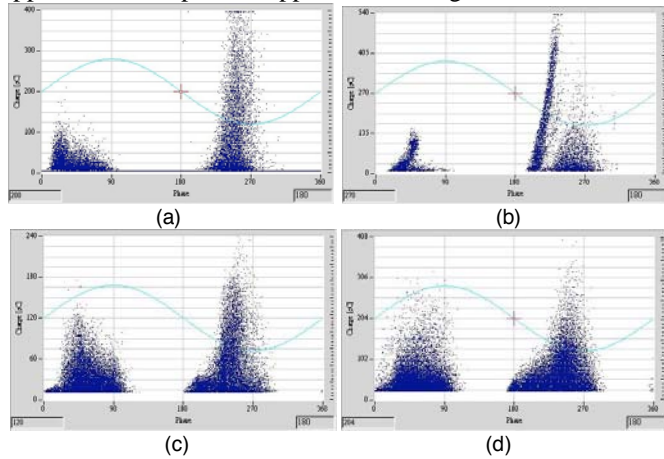
Figure 7 phase-resolved pattern

Figure 7 shows the partial discharge pattern of specimen with left void. The areas of partial discharge are 0° to 90° and 180° to 270° , and the magnitude of partial discharge in negative half cycle is larger than that of positive half cycle. The characteristics of these partial discharge patterns are alike to external partial discharge due to their peak partial discharge appears near the peak of applied AC voltage.

The phase-resolved pattern with left void is the only one with asymmetry, and its peak magnitude of partial discharge locate close to the peak of reference voltage. The phase-resolved pattern with left tape is corona-like pattern. The phase-resolved patterns with wrong position of stress cone and pricked needle are quite similar, and can only be distinguished by their envelope. Table 1 summarize the properties of these defects.

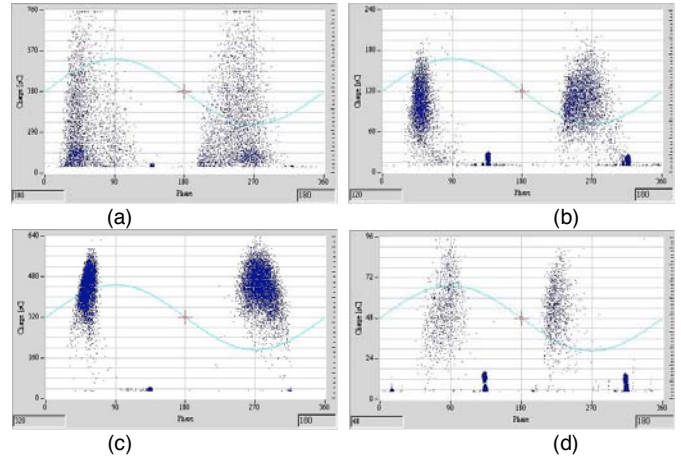
Figure 8 phase-resolved pattern

Figure 8 shows the partial discharge pattern of specimen with left tape on the insulation. The areas of partial discharge are 0° to 90° and 180° to 270° . The intensities of partial discharge activities in both half cycles are similar to each other. One of peak magnitudes locates at the center of first/third quarter, and the other locates at the positive/negative peak of reference voltage. The characteristics of these partial discharge patterns are alike to corona due to the cloud like pattern.
